Re: City Sidewalk Inventory and Condition Assessment Project Report

Project Overview and Details of Data Collected and Items Delivered to the City

Project Overview

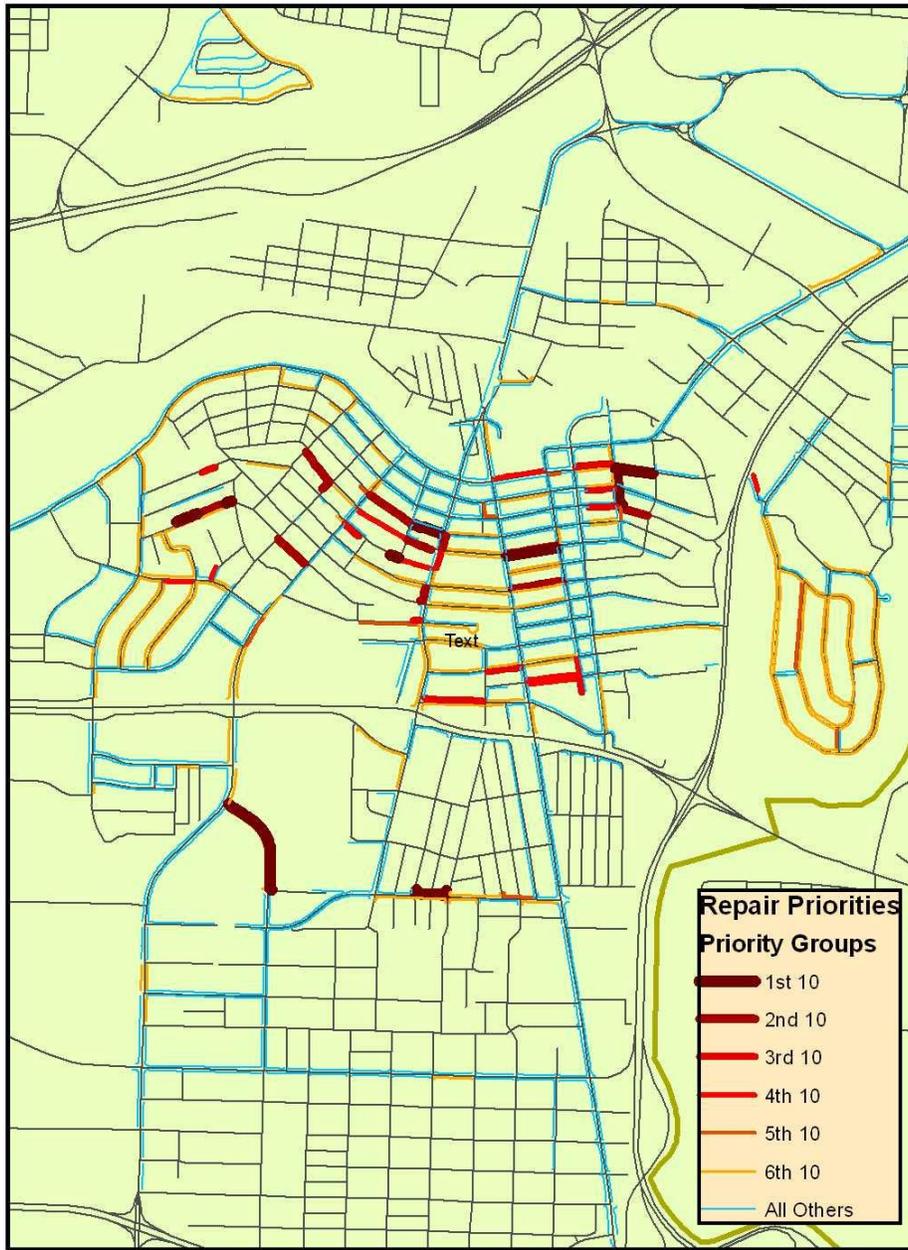
A GIS line feature class shape file named SW_Priorities containing the above information was supplied to the City. A map showing the top fifty locations for sidewalk repair based on the Priority Score is shown in Figure 1.

Figure 1: Sidewalk Repair Priority Groups

Based on these figures, the cost to repair the ten segments in Priority Group 1 is \$54,000. The estimated cost to repair damaged panels for the entire City is \$321,500. Note that this figure may underestimate the actual cost because in some cases it may be desirable to replace adjacent panels to restore grade, or replace additional panels exhibiting distress while working on a segment. Also, this figure does not include costs to install ramps at intersections where none currently exist, retrofit warning panels into existing ramps, address driveway ramp issues. It also does not include the cost of relocating objects creating sidewalk encroachment issues.
